BOILER TUBE FAILURE ANALYSIS

INVESTIGAGING THE CAUSES OF BOILER TUBE FAILURES AT HARARE

THERMAL POWER STATION

A third year project submitted in partial fulfilment of the requirements of the BSc

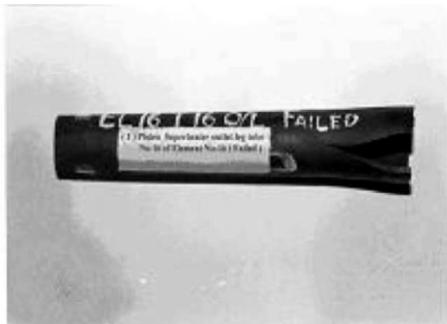
Figure 19 thick lip

The visual examination of the failed tubes reveals that the failure is “thick lip” wide-open burst (Figure 19). The outside diameter surface is covered with adherent scale and a uniform thin adherent white deposit is found on the inner side (Figure 20) Considerable swelling and reduction in wall thickness of the tube are observed in the area of the burst.

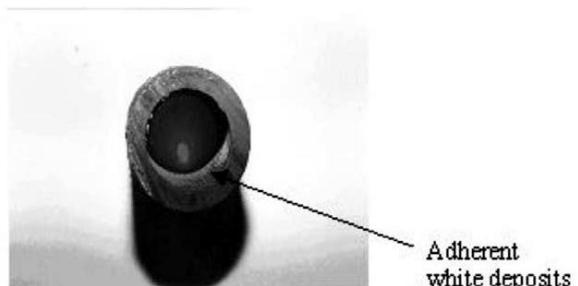
Figure 20 adherent white deposits

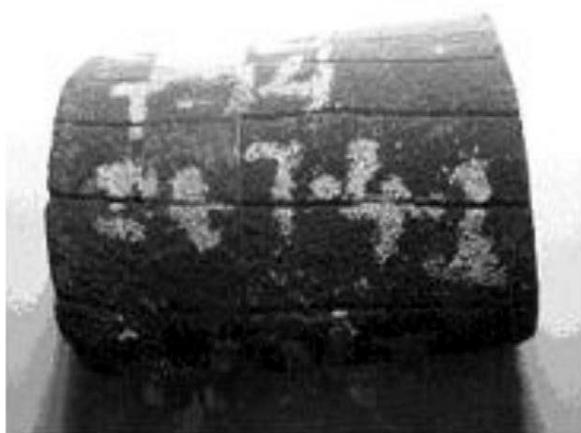
Figure 21 outer cracking

The unfailed service exposed tube adjacent to the failed tube reveals considerable bulging and thick outside scale with longitudinal scale cracking at the outer surface (Figure 21). No thin adherent white deposit was found inside in the service exposed tube.

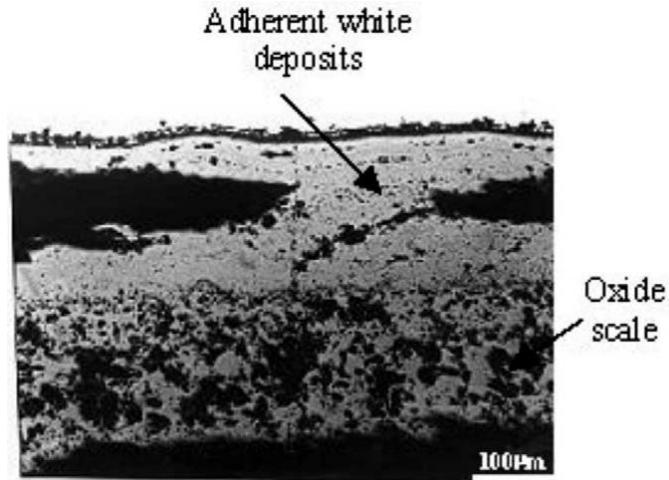
Figure 22 Cross sectional view of the unetched sample showing white deposits and oxide scale at inner surface.

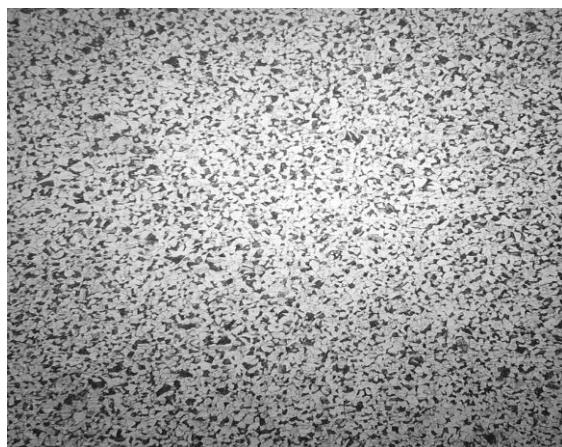
Figure 23 oriented creep cavities

The microstructure at the fracture tip of the failed tube shows numerous oriented creep cavities at the grain boundaries (Figure 23). The microstructure of the adjacent service exposed tube shows few isolated creep cavities at the grain boundaries (Figure. 24).

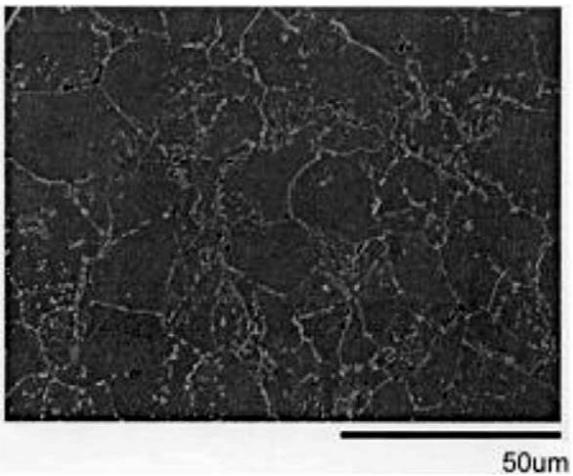
Figure 24 photograph showing grain boundaries
