BOILER TUBE FAILURE ANALYSIS

INVESTIGAGING THE CAUSES OF BOILER TUBE FAILURES AT HARARE

THERMAL POWER STATION

A third year project submitted in partial fulfilment of the requirements of the BSc

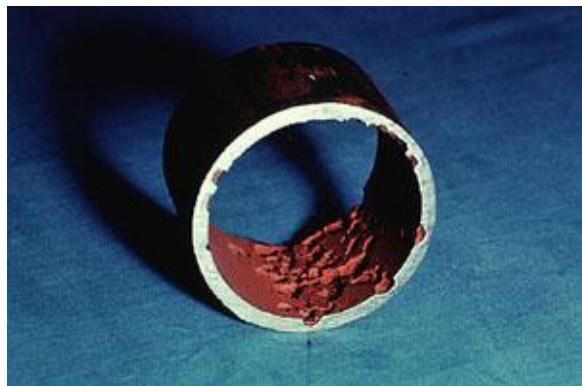
Figure 2 oxygen pitting

Water tube economizers are often subject to the serious damage of oxygen pitting (see Figure 2). The most severe damage occurs at the economizer inlet and, when present, at the tube weld seams. Where economizers are installed, effective deaerating heater operation is absolutely essential. The application of a fast-acting oxygen scavenger, such as catalysed sodium sulphite, also helps protect this vital part of the boiler.

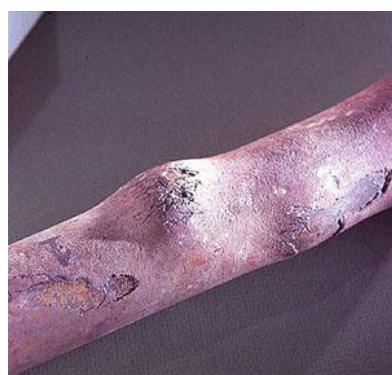
Figure 3 overheating

When tube failures occur due to overheating and plastic flow (conditions commonly associated with deposits), the cause is usually identified by the deposits which remain, as shown in Figure 3 (Ghosh et al. 2010). An accurate analysis of the deposits indicates the

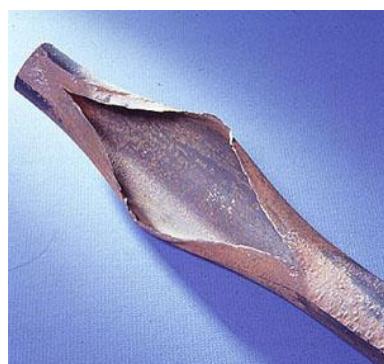
Figure 4 Thick lip

When tube failures occur due to overheating, a careful examination of the failed tube section reveals whether the failure is due to rapid escalation in tube wall temperature or a long-term, gradual build-up of deposit. When conditions cause a rapid elevation in metal temperature to 1600°F or above, plastic flow conditions are reached and a violent rupture occurs. Ruptures characterized by thin, sharp edges are identified as "thin-lipped" bursts (see Figure 4).

Violent bursts of the thin-lipped variety occur when water circulation in the tube is interrupted by blockage or by circulation failure caused by low water levels. In some steam drum designs, water level is extremely critical because the baffling may isolate a generating section of the boiler when the steam drum water level falls below a certain point.

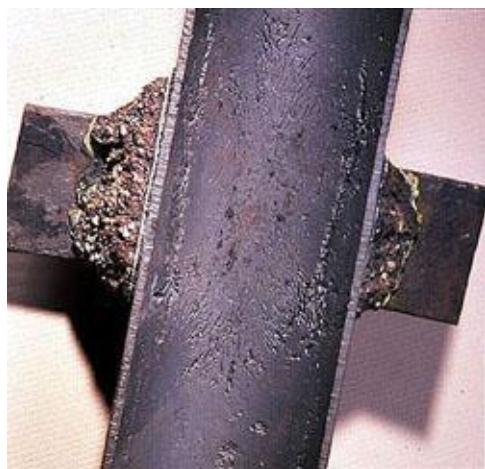
Figure 6 stress induced corrosion

Certain portions of the boiler can be very susceptible to corrosion as a result of stress from mechanical forces applied during the manufacturing and fabrication processes. Damage is commonly visible in stressed components, such as rolled tube ends, threaded bolts, and cyclone separators(Noor & Kadirgama 2010). However, corrosion can also occur at weld attachments throughout the boiler (see Figure 6) and can remain undetected until failure occurs. Regular inspection for evidence of corrosion, particularly in the windbox area of Kraft recovery boilers, is recommended because of the potential for an explosion caused by a tube leak.

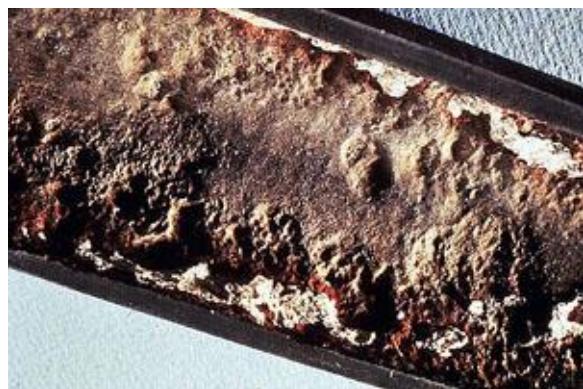
Figure 7 caustic attack

The thinning caused by caustic attack assumes irregular patterns and is often referred to ascaustic gouging (see Figure 7). When deposits are removed from the tube surface during examination, the characteristic gouges are very evident, along with the white salts deposit which usually outlines the edges of the original deposition area. The whitish deposit is sodium carbonate, the residue of caustic soda reacting with carbon dioxide in the air.

While caustic attack is sometimes referred to as caustic pitting, the attack physically appears as irregular gouging or thinning and should not be confused with the concentrated, localized pit penetration representative of oxygen or acid attack.

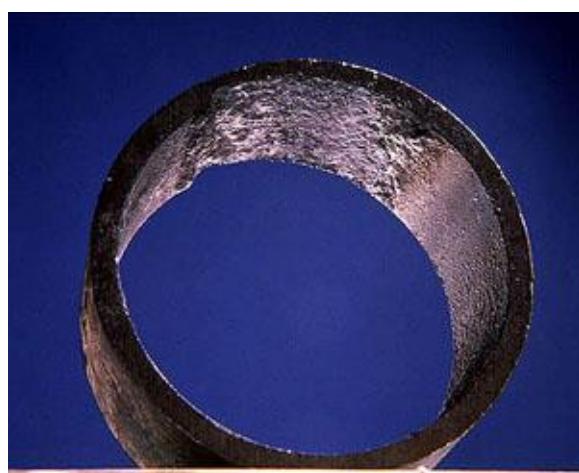
Figure 8 steam blanketing

A number of conditions permit stratified flow of steam and water in a given tube, which usually occurs in a low heat input zone of the boiler. This problem is influenced by the angle of the affected tubes, along with the actual load maintained on the boiler. Stratification occurs when, for any reason, velocity is not sufficient to maintain turbulence or thorough mixing of water and steam during passage through the tubes. Stratification most commonly occurs in sloped tubes (Figure 8) located away from the radiant heat zone of the boiler, where heat input is low and positive circulation in the tubes may be lacking.(Sohail & Mustafa 2007)

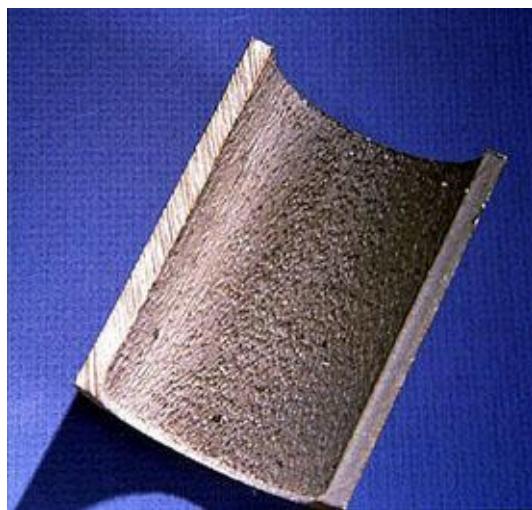
Figure 9 acid attack

Acid attack of boiler tubes and drums is usually in the form of general thinning of all surfaces. This results in a visually irregular surface appearance, as shown in Figure 9. Smooth surfaces appear at areas of flow where the attack has been intensified. In severe occurrences, other components, such as baffling, nuts and bolts, and other stressed areas, may be badly damaged or destroyed, leaving no doubt as to the source of the problem.(Tcr 2004)

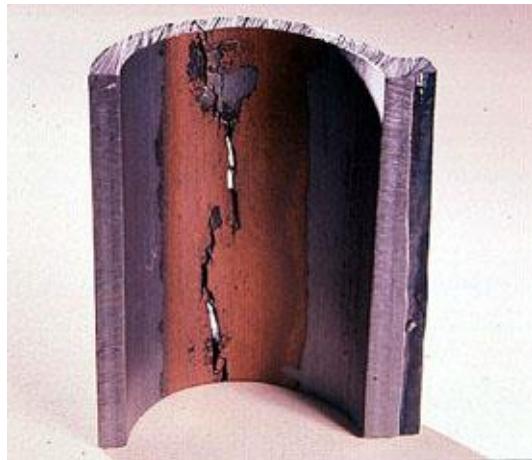
Figure 10 copper corosssion

Pitting of boiler drums and tube banks has been encountered due to metallic copper deposits, formed during acid cleaning procedures which do not completely compensate for the amount of copper oxides in the original deposits. Dissolved copper may be plated out on freshly cleaned steel surfaces, eventually establishing anodic corrosion areas and forming pits very similar in form and appearance to those caused by oxygen.(Port et al. n.d.)

Copper deposits and temperatures over 1600°F can cause liquid metal embrittlement. Weld repair of a tube containing copper deposits leads to the failure shown in Figure 10.

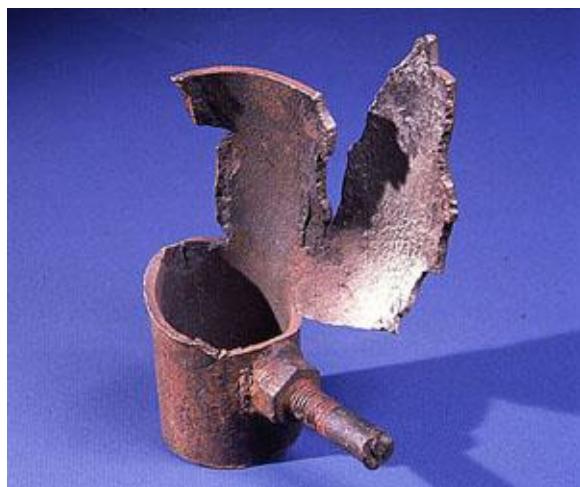
Figure 11 hydrogen attack

Since around 1960, hydrogen attack, or embrittlement, has been encountered with increasing frequency in high-pressure, high-purity systems. It is not encountered in the average industrial plant because the problem usually occurs only in units operating at pressures of 1500 psig or higher.(Kimura et al. 2011)

excessive pressure develops within the metal structure, causing the metal to rupture along the crystalline boundaries where methane has formed. The cracking that develops is primarily intercrystalline or intergranular in nature, the metallic area affected becoming decarburized in the process. Failure occurs when the ruptured section can no longer withstand the internal pressure. Ruptures are violent and sudden, and can be disastrous (see Figure 11). Failed sections of tubing are cracked in the intergranular mode and decarburized, but usually retain the original dimensions or thickness of the tubing material.

Surveys of units operating at these pressures and under these conditions have generally indicated that the application of a coordinated pH/phosphate control will lessen the possibility of hydrogen embrittlement. This is due primarily to the improved buffering of the boiler water with phosphate present.(Kimura et al. 2011)

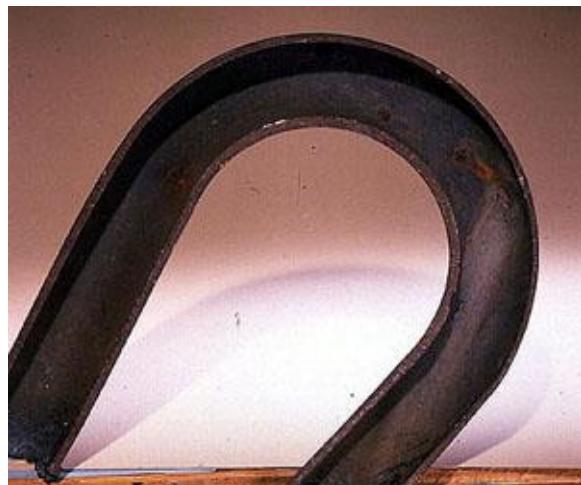
Figure 12 direct oxidation

Superheater tube failures are caused by a number of conditions, both mechanical and chemical. In any instance of superheater tube failure, analysis of the deposits found is an important factor in solving the problem. Magnetic oxide deposits at the point of failure are a direct indication of oxidation of the tube metal (see Figure 12). This oxidation occurs during overheating where metal temperatures exceed the design temperature and the steel enters into a direct reaction with the steam to form magnetic iron oxide with hydrogen release. When the deposits found in the area of failure are primarily iron oxide, it may be necessary to explore a number of operating conditions in order to determine the initial cause. (Getwater 2015)
